Report No. CETHA-BC-CR-89355

Task Order 2 Enhanced Preliminary Assessment

FORT HOLABIRD
CRIME RECORDS CENTER
BALTIMORE, MARYLAND

USATHAMA Task Order 2
ENHANCED PRELIMINARY ASSESSMENT REPORT
FORT HOLABIRD
CRIME RECORDS CENTER
CITY OF BALTIMORE, MARYLAND
Contract No. DAAA15-88-D-0007

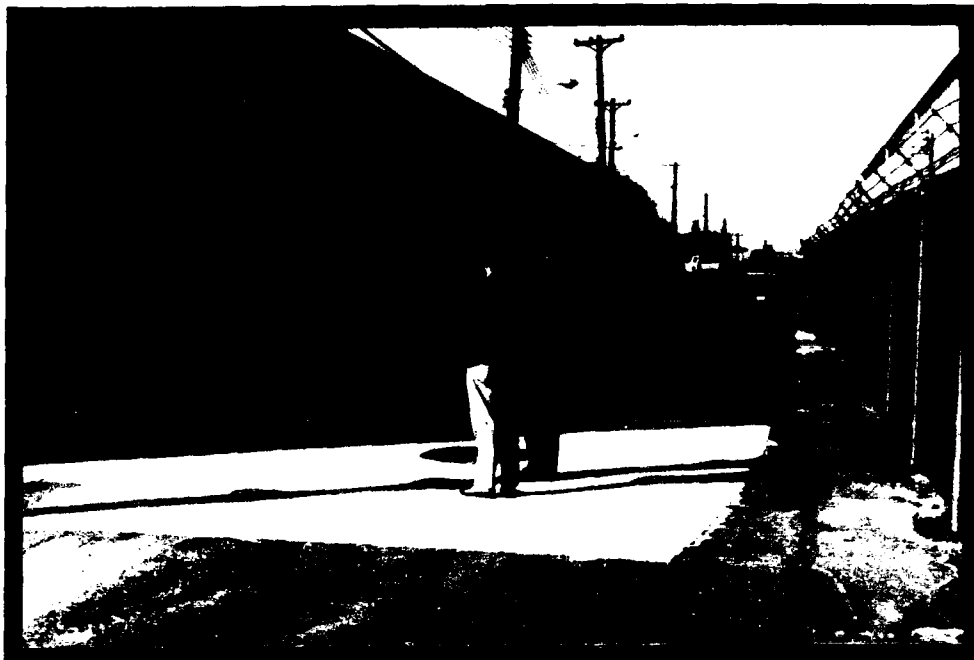
8. NEW UST LOCATION

A newly installed (1989 construction), 4,000-gal underground storage tank (UST) is located just north of the northeastern corner of Building 305 (photo 8). This tank replaced the in-ground storage tank that was formerly located adjacent to the northeastern corner of this building. The new tank stores No. 2 fuel oil used to fuel the boiler in the building. In contrast to the three former in-ground storage tanks, this tank is double-walled steel, cathode protected, resin/tar-coated, and wrapped. Even though the new tank has passed a leak test, its annular space is currently monitored for leakage by a new fluid detection system. It has continuous automatic sensing equipment to detect liquid hydrocarbons or hydrocarbon vapors (photo 9). In addition, the new tank has three new monitoring wells, one on its western end and two on its eastern end, that can be used to manually sample groundwater.

There is no evidence of any present spills/leakage from the new tank. However, the location of this tank is in close proximity to the location of the former 6,000-gal in-ground storage tank that leaked an undetermined amount of fuel oil in the past. Nevertheless, no contamination has been detected from samples drawn from the monitoring wells nor from the continuous automatic sensing equipment.

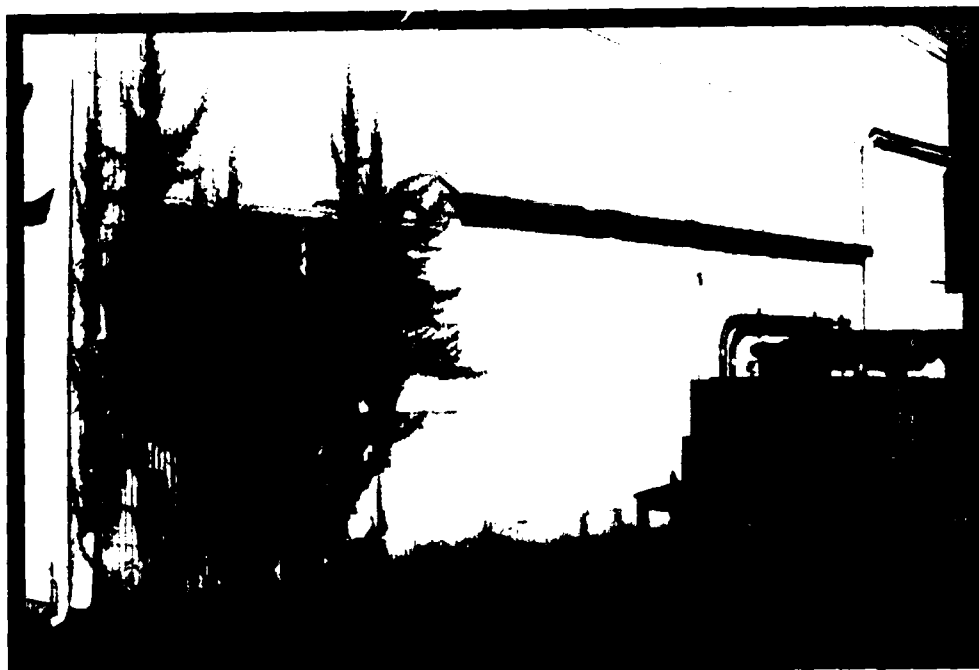
10. EMERGENCY GENERATOR AND UST

A 500-gal UST is located just east of Building 305 and contains diesel fuel to run an adjacent emergency electrical generator (photo 10). The tank is single-walled steel and 5 years old. It has three pipes, two vent pipes, and one fill pipe, that protrude above the ground. It is uncertain whether the UST has ever been leak tested.

There is no evidence of any past or present spills/leakage in this area; however, no monitoring system exists to verify this other than the monitoring wells associated with Building 305. In addition, no staining was observed around the three pipes that protrude above the ground.

The only storage tank requiring additional action is the 500-gal diesel fuel tank servicing the electrical generator at Building 305. This tank should be leak tested. If a leak is found, the tank should be removed and the contaminated soil excavated.

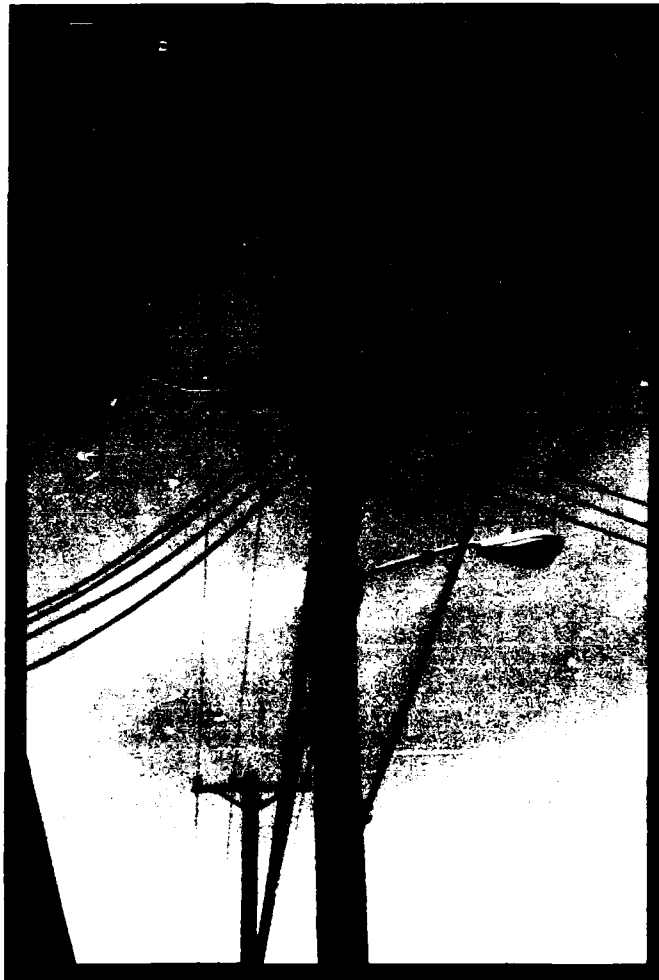
11. TRANSFORMER

There is only one electrical transformer at the CRC site. The transformer is Army owned and is located northeast of Building 305. Due to the age of the transformer, it may contain PCBs. Although the overall condition of the transformer is good, it is scheduled to be replaced by Fort Meade's Facilities Engineering and Maintenance Division.

There is no evidence of any past or present spills in this area. In addition, no transformer oil leaks or stains were observed on the pole or around its base.
